ASBESTOS REINSPECTION REPORT

Client	OCS M&E Services Ltd (Post Office)
Site	GLOUCESTER KINGS SQ CO, KINGS SQUARE GLOUCESTER, GL1 1AD
Date report issued	13th June 2025
Recommended Date for Reinspection	12th June 2026
Survey reference	J1187944
Lead surveyor	Ben Gilpin
Assistant surveyor	N/A
UPRN	901598

No. of Asbestos Risks Identified		
	Category A	0
	Category B	0
	Category C	9
	Category D	32
	Areas not accessed (Presumed asbestos)	0

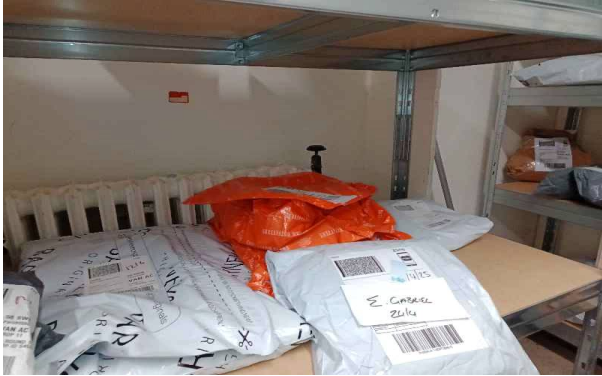
Item / Inspection Ref:	#3	Material Assessment	Product type:	1

Sample Ref:			Condition / Damage:	1		
Survey date:	12/06/2025		Surface Treatment:	0		
Date last inspected:	29/04/2025 14:28:26		Asbestos Type:	1		
Next inspection due:	12th June 2026		Material Score:	3		
Building:	901598 - Gloucester Kings Sq CO	Priority Assessment	Occupant Activity:	1		
Floor level:	Ground Floor		Location:	2		
Room:	002/Store		Accessibility:	0		
Position:	To radiator		Extent/amount:	0		1no.
Item Description:	Heating valve		Number of Occupants:	1		
Level of Identification:	PRESUMED		Frequency of Use:	3		
			Time in Area:	0		
			Maintenance activity:	0		
Action:	Monitor and manage	Frequency of Maintenance:	0			
RISK CODE:	D	Priority Score:	4			
		Total Score:	7			
Comments:					Material Status Change:	
					No Change

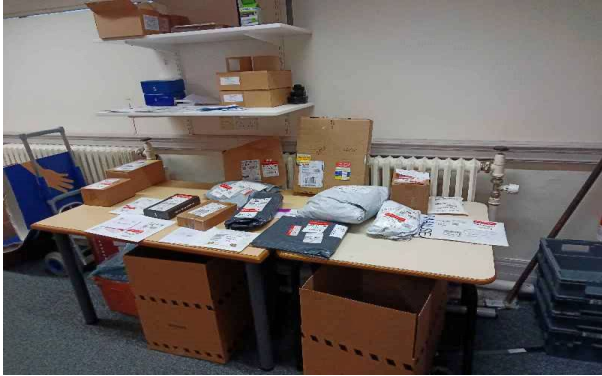
Item / Inspection Ref:	#4	Material Assessment	Product type:	1

Sample Ref:			Condition / Damage:	1		
Survey date:	12/06/2025		Surface Treatment:	0		
Date last inspected:	29/04/2025 14:28:26		Asbestos Type:	1		
Next inspection due:	12th June 2026		Material Score:	3		
Building:	901598 - Gloucester Kings Sq CO	Priority Assessment	Occupant Activity:	1		
Floor level:	Ground Floor		Location:	1		
Room:	030/Cashiers		Accessibility:	0		
Position:	To radiators		Extent/amount:	0		7no.
Item Description:	Heating valves		Number of Occupants:	2		
Level of Identification:	PRESUMED		Frequency of Use:	3		
			Time in Area:	3		
			Maintenance activity:	0		
Action:	Monitor and manage	Frequency of Maintenance:	0			
RISK CODE:	D	Priority Score:	5			
		Total Score:	8			
Comments:					Material Status Change:	
					No Change

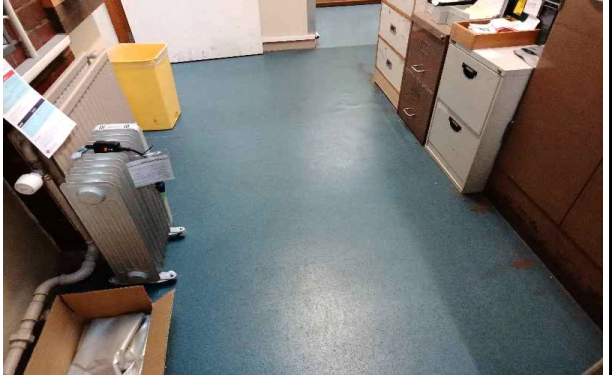
Item / Inspection Ref:	#5	Material Assessment	Product type:	1

Sample Ref:			Condition / Damage:	1		
Survey date:	12/06/2025		Surface Treatment:	0		
Date last inspected:	29/04/2025 14:28:26		Asbestos Type:	1		
Next inspection due:	12th June 2026		Material Score:	3		
Building:	901598 - Gloucester Kings Sq CO	Priority Assessment	Occupant Activity:	1		
Floor level:	Ground Floor		Location:	2		
Room:	005/Office		Accessibility:	0		
Position:	Floor		Extent/amount:	2		10m2
Item Description:	Bitumen floor adhesive		Number of Occupants:	1		
Level of Identification:	PRESUMED		Frequency of Use:	3		
			Time in Area:	0		
			Maintenance activity:	0		
Action:	Monitor and manage	Frequency of Maintenance:	0			
RISK CODE:	D	Priority Score:	5			
		Total Score:	8			
Comments:	Presumed to remain beneath modern blue vinyl floor covering				Material Status Change:	
				No Change

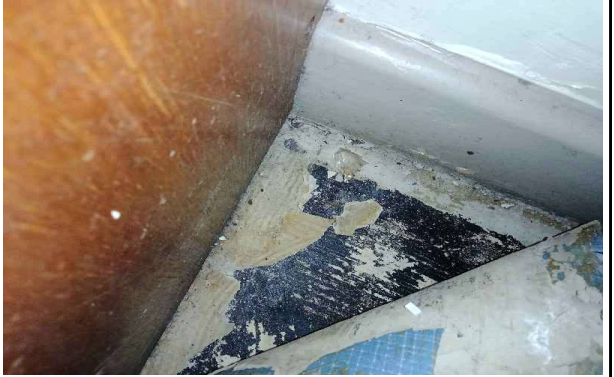
Item / Inspection Ref:	#6	Material Assessment	Product type:	1

Sample Ref:			Condition / Damage:	1		
Survey date:	12/06/2025		Surface Treatment:	0		
Date last inspected:	29/04/2025 14:28:26		Asbestos Type:	1		
Next inspection due:	12th June 2026		Material Score:	3		
Building:	901598 - Gloucester Kings Sq CO	Priority Assessment	Occupant Activity:	1		
Floor level:	Ground Floor		Location:	2		
Room:	004/Office		Accessibility:	0		
Position:	Floor beneath modern blue vinyl floor covering		Extent/amount:	2		12m2
Item Description:	Bitumen floor adhesive		Number of Occupants:	1		
Level of Identification:	PRESUMED		Frequency of Use:	3		
			Time in Area:	0		
			Maintenance activity:	0		
Action:	Monitor and manage	Frequency of Maintenance:	0			
RISK CODE:	D	Priority Score:	5			
		Total Score:	8			
Comments:					Material Status Change:	
				No Change

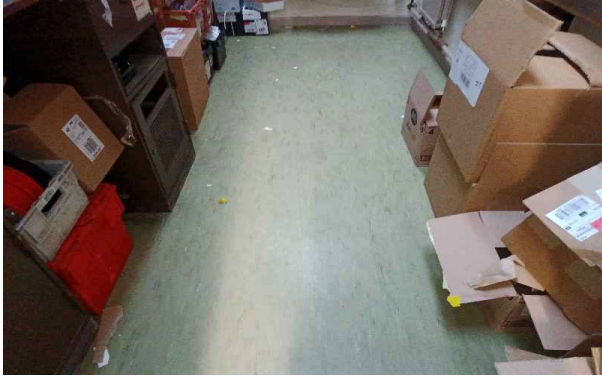
Item / Inspection Ref:	#7	Material Assessment	Product type:	1

Sample Ref:			Condition / Damage:	1		
Survey date:	12/06/2025		Surface Treatment:	0		
Date last inspected:	29/04/2025 14:28:26		Asbestos Type:	1		
Next inspection due:	12th June 2026		Material Score:	3		
Building:	901598 - Gloucester Kings Sq CO	Priority Assessment	Occupant Activity:	1		
Floor level:	Ground Floor		Location:	2		
Room:	003/Office		Accessibility:	0		
Position:	Below Lino		Extent/amount:	2		12m2
Item Description:	Residual adhesive		Number of Occupants:	1		
Level of Identification:	PRESUMED		Frequency of Use:	3		
			Time in Area:	0		
			Maintenance activity:	0		
Action:	Monitor and manage	Frequency of Maintenance:	0			
RISK CODE:	D	Priority Score:	5			
		Total Score:	8			
Comments:					Material Status Change:	
					No Change

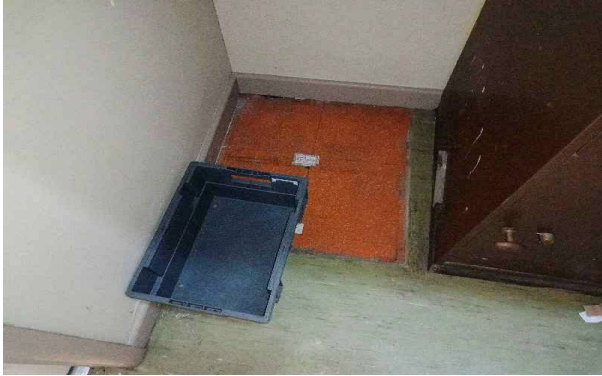
Item / Inspection Ref:	#8	Material Assessment	Product type:	1

Sample Ref:			Condition / Damage:	1		
Survey date:	12/06/2025		Surface Treatment:	0		
Date last inspected:	29/04/2025 14:28:26		Asbestos Type:	1		
Next inspection due:	12th June 2026		Material Score:	3		
Building:	901598 - Gloucester Kings Sq CO	Priority Assessment	Occupant Activity:	1		
Floor level:	Ground Floor		Location:	2		
Room:	003/Office		Accessibility:	1		
Position:	Floor beneath counter		Extent/amount:	1		1m2
Item Description:	Orange floor tiles and adhesive		Number of Occupants:	1		
Level of Identification:	PRESUMED		Frequency of Use:	3		
			Time in Area:	0		
			Maintenance activity:	0		
Action:	Monitor and manage	Frequency of Maintenance:	0			
RISK CODE:	D	Priority Score:	5			
		Total Score:	8			
Comments:					Material Status Change:	
					No Change

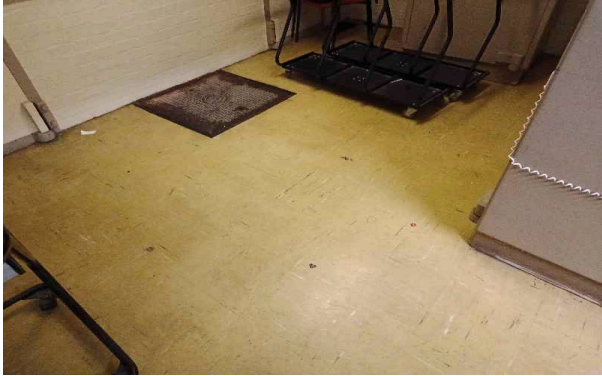
Item / Inspection Ref:	#9	Material Assessment	Product type:	1

Sample Ref:			Condition / Damage:	1		
Survey date:	12/06/2025		Surface Treatment:	0		
Date last inspected:	29/04/2025 14:28:26		Asbestos Type:	1		
Next inspection due:	12th June 2026		Material Score:	3		
Building:	901598 - Gloucester Kings Sq CO	Priority Assessment	Occupant Activity:	1		
Floor level:	Ground Floor		Location:	2		
Room:	006/Safe Room		Accessibility:	1		
Position:	Floor		Extent/amount:	2		15m2
Item Description:	Yellow floor tiles and adhesive		Number of Occupants:	1		
Level of Identification:	PRESUMED		Frequency of Use:	3		
Action:	Monitor and manage		Time in Area:	0		
			Maintenance activity:	0		
		Frequency of Maintenance:	0			
RISK CODE:	D	Priority Score:	5			
		Total Score:	8			
Comments:					Material Status Change:	
					No Change

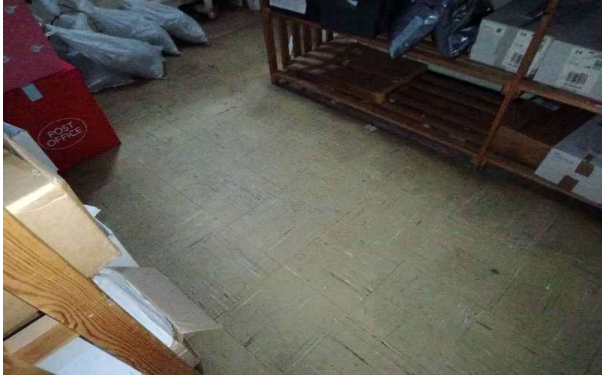
Item / Inspection Ref:	#10	Material Assessment	Product type:	1

Sample Ref:			Condition / Damage:	1		
Survey date:	12/06/2025		Surface Treatment:	0		
Date last inspected:	29/04/2025 14:28:26		Asbestos Type:	1		
Next inspection due:	12th June 2026		Material Score:	3		
Building:	901598 - Gloucester Kings Sq CO	Priority Assessment	Occupant Activity:	1		
Floor level:	Ground Floor		Location:	2		
Room:	007/Stock Room		Accessibility:	1		
Position:	Floor		Extent/amount:	2		12m2
Item Description:	Yellow floor tiles and adhesive		Number of Occupants:	1		
Level of Identification:	PRESUMED		Frequency of Use:	3		
Action:	Monitor and manage		Time in Area:	0		
			Maintenance activity:	0		
		Frequency of Maintenance:	0			
RISK CODE:	D	Priority Score:	5			
		Total Score:	8			
Comments:					Material Status Change:	
					No Change

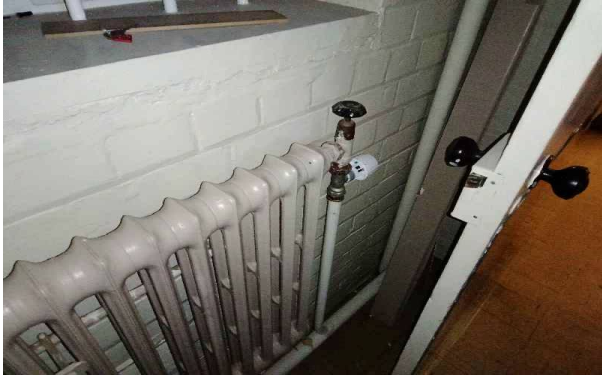
Item / Inspection Ref:	#11	Material Assessment	Product type:	1

Sample Ref:			Condition / Damage:	1		
Survey date:	12/06/2025		Surface Treatment:	0		
Date last inspected:	29/04/2025 14:28:26		Asbestos Type:	1		
Next inspection due:	12th June 2026		Material Score:	3		
Building:	901598 - Gloucester Kings Sq CO	Priority Assessment	Occupant Activity:	1		
Floor level:	Ground Floor		Location:	2		
Room:	007/Stock Room		Accessibility:	0		
Position:	To radiator		Extent/amount:	0		1no.
Item Description:	Heating valve		Number of Occupants:	1		
Level of Identification:	PRESUMED		Frequency of Use:	3		
			Time in Area:	0		
			Maintenance activity:	0		
Action:	Monitor and manage	Frequency of Maintenance:	0			
RISK CODE:	D	Priority Score:	4			
		Total Score:	7			
Comments:					Material Status Change:	
					No Change

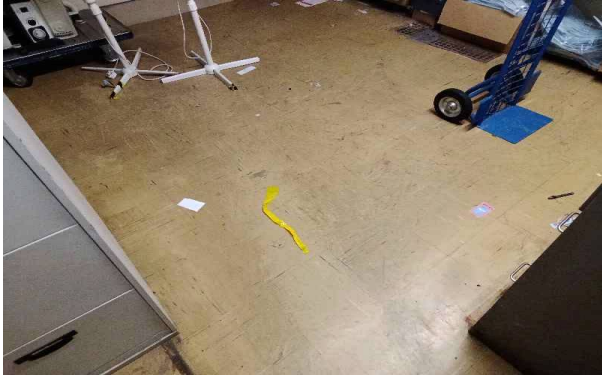
Item / Inspection Ref:	#12	Material Assessment	Product type:	1

Sample Ref:			Condition / Damage:	1		
Survey date:	12/06/2025		Surface Treatment:	0		
Date last inspected:	29/04/2025 14:28:26		Asbestos Type:	1		
Next inspection due:	12th June 2026		Material Score:	3		
Building:	901598 - Gloucester Kings Sq CO	Priority Assessment	Occupant Activity:	1		
Floor level:	Ground Floor		Location:	2		
Room:	008/Stock Room		Accessibility:	1		
Position:	Floor		Extent/amount:	2		20m2
Item Description:	Yellow floor tiles and adhesive		Number of Occupants:	1		
Level of Identification:	PRESUMED		Frequency of Use:	3		
			Time in Area:	0		
			Maintenance activity:	0		
Action:	Monitor and manage	Frequency of Maintenance:	0			
RISK CODE:	D	Priority Score:	5			
		Total Score:	8			
Comments:					Material Status Change:	
					No Change

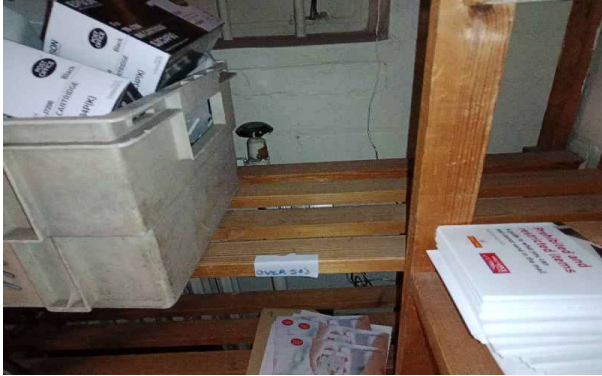
Item / Inspection Ref:	#13	Material Assessment	Product type:	1

Sample Ref:			Condition / Damage:	1		
Survey date:	12/06/2025		Surface Treatment:	0		
Date last inspected:	29/04/2025 14:28:26		Asbestos Type:	1		
Next inspection due:	12th June 2026		Material Score:	3		
Building:	901598 - Gloucester Kings Sq CO	Priority Assessment	Occupant Activity:	1		
Floor level:	Ground Floor		Location:	2		
Room:	008/Stock Room		Accessibility:	0		
Position:	To radiator		Extent/amount:	0		1no.
Item Description:	Heating valve		Number of Occupants:	1		
Level of Identification:	PRESUMED		Frequency of Use:	3		
Action:	Monitor and manage		Time in Area:	0		
			Maintenance activity:	0		
		Frequency of Maintenance:	0			
RISK CODE:	D	Priority Score:	4			
		Total Score:	7			
Comments:					Material Status Change:	
					No Change

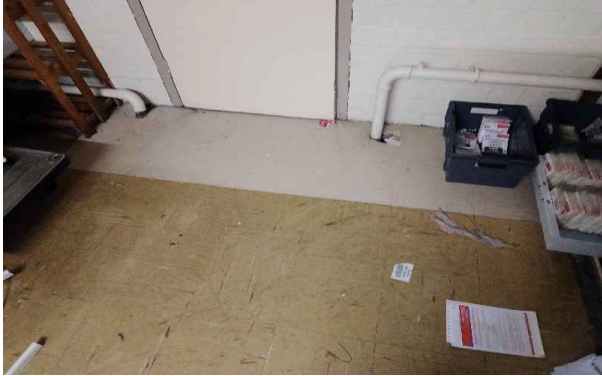
Item / Inspection Ref:	#14	Material Assessment	Product type:	1

Sample Ref:			Condition / Damage:	1		
Survey date:	12/06/2025		Surface Treatment:	0		
Date last inspected:	29/04/2025 14:28:26		Asbestos Type:	1		
Next inspection due:	12th June 2026		Material Score:	3		
Building:	901598 - Gloucester Kings Sq CO	Priority Assessment	Occupant Activity:	1		
Floor level:	Ground Floor		Location:	2		
Room:	008/Stock Room		Accessibility:	1		
Position:	Floor		Extent/amount:	1		3m2
Item Description:	Beige floor tiles and adhesive		Number of Occupants:	1		
Level of Identification:	PRESUMED		Frequency of Use:	3		
Action:	Monitor and manage		Time in Area:	0		
			Maintenance activity:	0		
		Frequency of Maintenance:	0			
RISK CODE:	D	Priority Score:	5			
		Total Score:	8			
Comments:					Material Status Change:	
					No Change

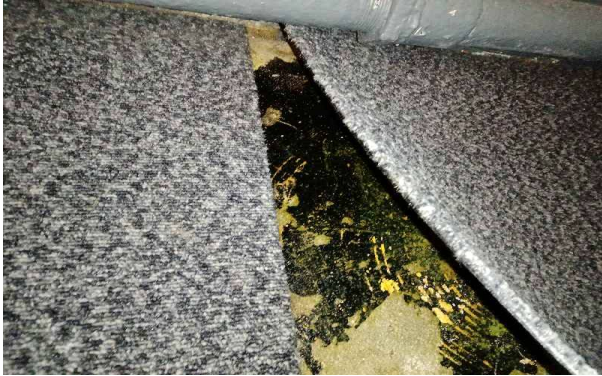
Item / Inspection Ref:	#17	Material Assessment	Product type:	1

Sample Ref:			Condition / Damage:	1						
Survey date:	12/06/2025		Surface Treatment:	0						
Date last inspected:	29/04/2025 14:28:26		Asbestos Type:	1						
Next inspection due:	12th June 2026		Material Score:	3						
Building:	901598 - Gloucester Kings Sq CO	Priority Assessment	Occupant Activity:	1		<table border="1"> <tr><td colspan="2">Material Status Change:</td></tr> <tr><td colspan="2">No Change</td></tr> </table>	Material Status Change:		No Change	
Material Status Change:										
No Change										
Floor level:	Ground Floor		Location:	2						
Room:	017/Staff Room		Accessibility:	0						
Position:	Floor below carpet		Extent/amount:	2	25m2					
Item Description:	Bitumen floor adhesive		Number of Occupants:	2						
Level of Identification:	PRESUMED		Frequency of Use:	3						
		Time in Area:	0							
Action:	Monitor and manage	Maintenance activity:	0							
		Frequency of Maintenance:	0							
RISK CODE:	D		Priority Score:	5						
			Total Score:	8						
Comments:

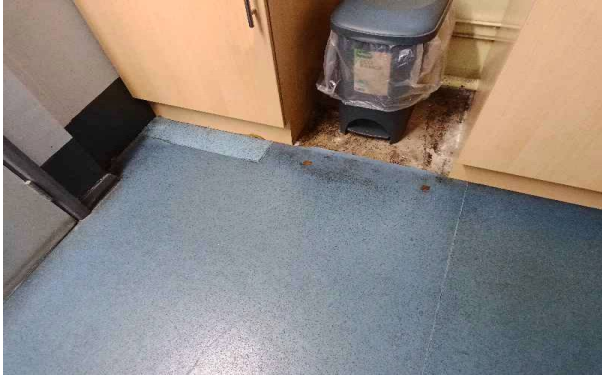
Item / Inspection Ref:	#18	Material Assessment	Product type:	1

Sample Ref:			Condition / Damage:	1						
Survey date:	12/06/2025		Surface Treatment:	0						
Date last inspected:	29/04/2025 14:28:26		Asbestos Type:	1						
Next inspection due:	12th June 2026		Material Score:	3						
Building:	901598 - Gloucester Kings Sq CO	Priority Assessment	Occupant Activity:	1		<table border="1"> <tr><td colspan="2">Material Status Change:</td></tr> <tr><td colspan="2">No Change</td></tr> </table>	Material Status Change:		No Change	
Material Status Change:										
No Change										
Floor level:	Ground Floor		Location:	2						
Room:	018/Kitchen		Accessibility:	1						
Position:	Floor		Extent/amount:	2	25m2					
Item Description:	Bitumen floor adhesive		Number of Occupants:	2						
Level of Identification:	PRESUMED		Frequency of Use:	3						
		Time in Area:	0							
Action:	Monitor and manage	Maintenance activity:	0							
		Frequency of Maintenance:	0							
RISK CODE:	D		Priority Score:	5						
			Total Score:	8						
Comments:	Presumed to remain beneath modern blue vinyl floor covering to entire room

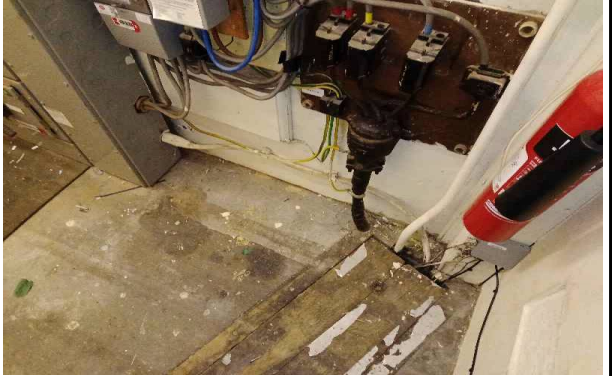
Item / Inspection Ref:	#19	Material Assessment	Product type:	2

Sample Ref:			Condition / Damage:	1		
Survey date:	12/06/2025		Surface Treatment:	2		
Date last inspected:	29/04/2025 14:28:26		Asbestos Type:	1		
Next inspection due:	12th June 2026		Material Score:	6		
Building:	901598 - Gloucester Kings Sq CO	Priority Assessment	Occupant Activity:	1		
Floor level:	Ground Floor		Location:	2		
Room:	021/Electrical Switch Room		Accessibility:	1		
Position:	Mains incoming cable		Extent/amount:	1		5lm
Item Description:	Cable wrap		Number of Occupants:	1		
Level of Identification:	PRESUMED		Frequency of Use:	0		
			Time in Area:	0		
			Maintenance activity:	0		
			Frequency of Maintenance:	0		
Action:	Monitor and manage		Priority Score:	4		
RISK CODE:	C	Total Score:	10			
Comments:					Material Status Change:	
					No Change

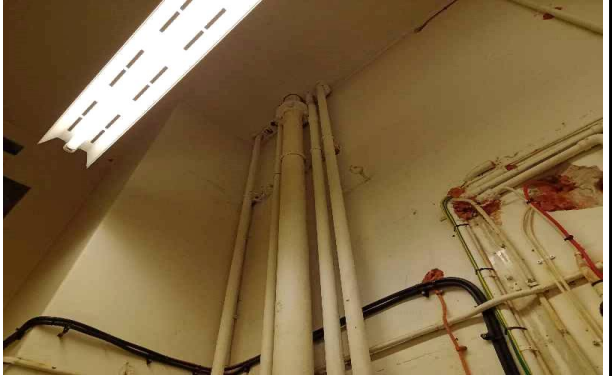
Item / Inspection Ref:	#20	Material Assessment	Product type:	2

Sample Ref:			Condition / Damage:	1		
Survey date:	12/06/2025		Surface Treatment:	1		
Date last inspected:	29/04/2025 14:28:26		Asbestos Type:	1		
Next inspection due:	12th June 2026		Material Score:	5		
Building:	901598 - Gloucester Kings Sq CO	Priority Assessment	Occupant Activity:	1		
Floor level:	Ground Floor		Location:	2		
Room:	021/Electrical Switch Room		Accessibility:	0		
Position:	Pipe flange gasket		Extent/amount:	0		1no.
Item Description:	Gasket		Number of Occupants:	1		
Level of Identification:	PRESUMED		Frequency of Use:	0		
			Time in Area:	0		
			Maintenance activity:	0		
			Frequency of Maintenance:	0		
Action:	Monitor and manage		Priority Score:	3		
RISK CODE:	D	Total Score:	8			
Comments:					Material Status Change:	
					No Change

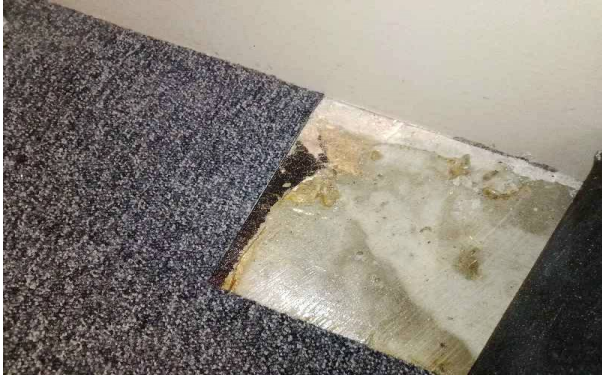
Item / Inspection Ref:	#21	Material Assessment	Product type:	1

Sample Ref:			Condition / Damage:	1		
Survey date:	12/06/2025		Surface Treatment:	0		
Date last inspected:	29/04/2025 14:28:26		Asbestos Type:	1		
Next inspection due:	12th June 2026		Material Score:	3		
Building:	901598 - Gloucester Kings Sq CO	Priority Assessment	Occupant Activity:	1		
Floor level:	Ground Floor		Location:	2		
Room:	023/Office		Accessibility:	0		
Position:	Floor		Extent/amount:	2		15m2
Item Description:	Bitumen floor adhesive		Number of Occupants:	1		
Level of Identification:	PRESUMED		Frequency of Use:	3		
			Time in Area:	0		
			Maintenance activity:	0		
Action:	Monitor and manage	Frequency of Maintenance:	0			
RISK CODE:	D	Priority Score:	5			
		Total Score:	8			
Comments:					Material Status Change:	
					No Change

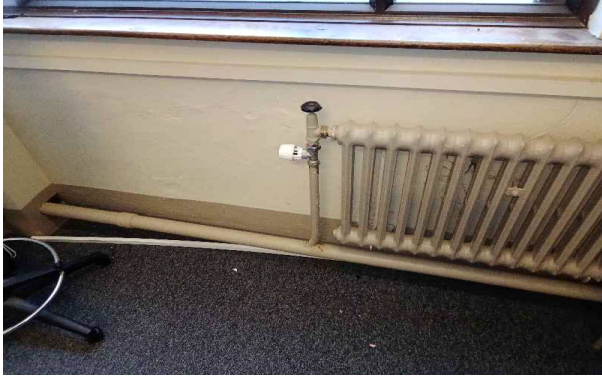
Item / Inspection Ref:	#22	Material Assessment	Product type:	1

Sample Ref:			Condition / Damage:	1		
Survey date:	12/06/2025		Surface Treatment:	0		
Date last inspected:	29/04/2025 14:28:26		Asbestos Type:	1		
Next inspection due:	12th June 2026		Material Score:	3		
Building:	901598 - Gloucester Kings Sq CO	Priority Assessment	Occupant Activity:	1		
Floor level:	Ground Floor		Location:	2		
Room:	024/Office		Accessibility:	0		
Position:	To radiator		Extent/amount:	0		1no.
Item Description:	Heating valve		Number of Occupants:	1		
Level of Identification:	PRESUMED		Frequency of Use:	3		
			Time in Area:	0		
			Maintenance activity:	0		
Action:	Monitor and manage	Frequency of Maintenance:	0			
RISK CODE:	D	Priority Score:	4			
		Total Score:	7			
Comments:					Material Status Change:	
					No Change

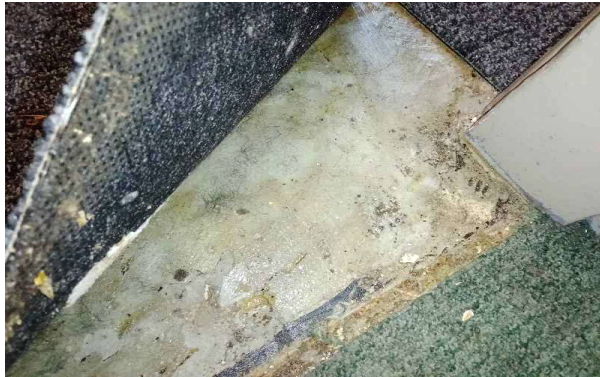
Item / Inspection Ref:	#23	Material Assessment	Product type:	1

Sample Ref:			Condition / Damage:	1			
Survey date:	12/06/2025		Surface Treatment:	0			
Date last inspected:	29/04/2025 14:28:26		Asbestos Type:	1			
Next inspection due:	12th June 2026		Material Score:	3			
Building:	901598 - Gloucester Kings Sq CO	Priority Assessment	Occupant Activity:	1			
Floor level:	Ground Floor		Location:	2			
Room:	024/Office		Accessibility:	0			
Position:	Floor below carpet		Extent/amount:	2	30m2		
Item Description:	Bitumen floor adhesive		Number of Occupants:	1			
Level of Identification:	PRESUMED		Frequency of Use:	3			
			Time in Area:	0			
			Maintenance activity:	0			
			Frequency of Maintenance:	0			
Action:	Monitor and manage		Priority Score:	5			
RISK CODE:	D		Total Score:	8			
Comments:							Material Status Change:
							No Change

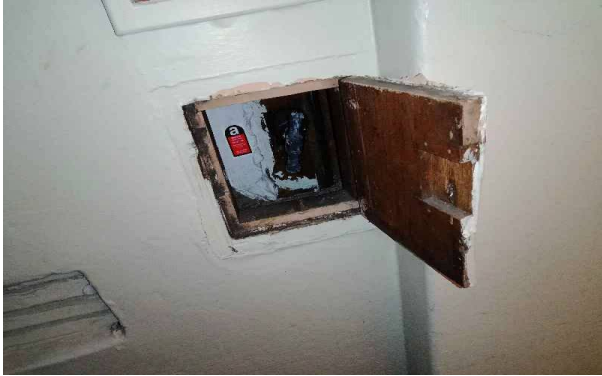
Item / Inspection Ref:	#25	Material Assessment	Product type:	1

Sample Ref:			Condition / Damage:	1		
Survey date:	12/06/2025		Surface Treatment:	1		
Date last inspected:	29/04/2025 14:28:26		Asbestos Type:	1		
Next inspection due:	12th June 2026		Material Score:	4		
Building:	901598 - Gloucester Kings Sq CO	Priority Assessment	Occupant Activity:	1		
Floor level:	Ground Floor		Location:	2		
Room:	026/Corridor		Accessibility:	1		
Position:	Within water tap hatch		Extent/amount:	1		1no.
Item Description:	Cement panel		Number of Occupants:	1		
Level of Identification:	PRESUMED		Frequency of Use:	3		
Action:	Monitor and manage		Time in Area:	0		
			Maintenance activity:	0		
		Frequency of Maintenance:	0			
RISK CODE:	C	Priority Score:	5			
		Total Score:	9			
Comments:					Material Status Change:	
					No Change

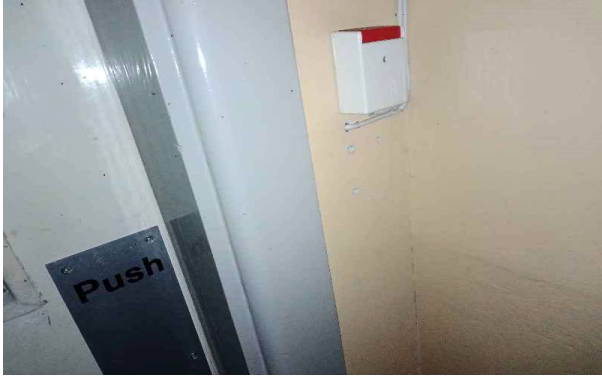
Item / Inspection Ref:	#26	Material Assessment	Product type:	2

Building	901598 - Gloucester Kings Sq CO									Room Notes
Floor Level	Room	Item/ Inspection Reference	Item Description	Item Location	Asbestos Type	Extent	Risk Category	Recommended Action	Material Status Change	
2nd Floor	002/Landing	#26	Insulating board	Wall to doorset 1174	Chrysotile	4m2	C	Encapsulate	Damaged	Area accessed via front left hand side stairwell

Sample Ref:	612549-2 (IMP181482)		Condition / Damage:	1		
Survey date:	12/06/2025		Surface Treatment:	2		
Date last inspected:	29/04/2025 14:28:26		Asbestos Type:	1		
Next inspection due:	12th June 2026		Material Score:	6		
Building:	901598 - Gloucester Kings Sq CO	Priority Assessment	Occupant Activity:	0		
Floor level:	2nd Floor		Location:	2		
Room:	002/Landing		Accessibility:	1		
Position:	Wall to doorset 1174		Extent/amount:	1		4m2
Item Description:	Insulating board		Number of Occupants:	1		
Level of Identification:	SAMPLED		Frequency of Use:	0		
Action:	Encapsulate		Time in Area:	0		
			Maintenance activity:	0		
		Frequency of Maintenance:	0			
RISK CODE:	C	Priority Score:	3			
		Total Score:	9			
Comments:	Encapsulate small holes to corridor side				Material Status Change:	
					Damaged

Building	Floor Level	Room	Item/Inspection Reference	Item Description	Risk Category	Recommended Action
901598 - Gloucester Kings Sq CO	2nd Floor	002/Landing	#26	Insulating board	C	Encapsulate

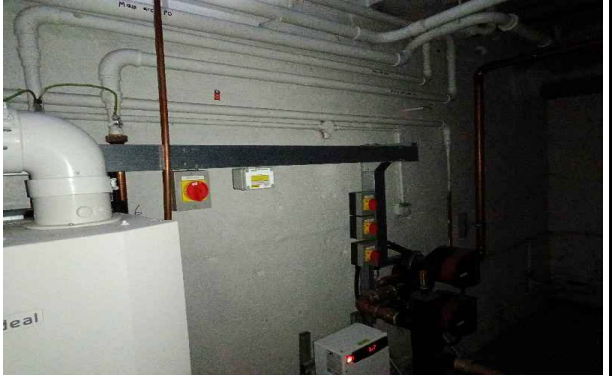
Item / Inspection Ref:	#27	Material Assessment	Product type:	3

Sample Ref:			Condition / Damage:	0		
Survey date:	12/06/2025		Surface Treatment:	2		
Date last inspected:	29/04/2025 14:28:26		Asbestos Type:	2		
Next inspection due:	12th June 2026		Material Score:	7		
Building:	901598 - Gloucester Kings Sq CO	Priority Assessment	Occupant Activity:	0		
Floor level:	Z-Sub Level 1		Location:	2		
Room:	001/Plant Room		Accessibility:	2		
Position:	Wall		Extent/amount:	2		20m2
Item Description:	Residue		Number of Occupants:	1		
Level of Identification:	PRESUMED		Frequency of Use:	0		
Action:	Monitor and manage		Time in Area:	0		
			Maintenance activity:	0		
		Frequency of Maintenance:	0			
RISK CODE:	C	Priority Score:	3			
		Total Score:	10			
Comments:					Material Status Change:	
					No Change

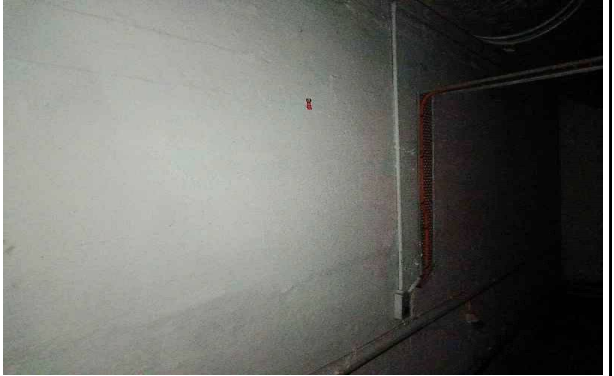
Item / Inspection Ref:	#28	Material Assessment	Product type:	3

Sample Ref:			Condition / Damage:	0		
Survey date:	12/06/2025		Surface Treatment:	2		
Date last inspected:	29/04/2025 14:28:26		Asbestos Type:	2		
Next inspection due:	12th June 2026		Material Score:	7		
Building:	901598 - Gloucester Kings Sq CO	Priority Assessment	Occupant Activity:	0		
Floor level:	Z-Sub Level 1		Location:	2		
Room:	001/Plant Room		Accessibility:	2		
Position:	Wall 2		Extent/amount:	2		20m2
Item Description:	Residue		Number of Occupants:	1		
Level of Identification:	PRESUMED		Frequency of Use:	0		
Action:	Monitor and manage		Time in Area:	0		
			Maintenance activity:	0		
		Frequency of Maintenance:	0			
RISK CODE:	C	Priority Score:	3			
		Total Score:	10			
Comments:					Material Status Change:	
					No Change

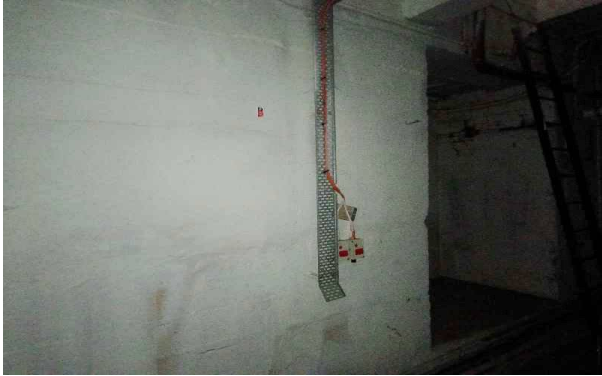
Item / Inspection Ref:	#29	Material Assessment	Product type:	3

Sample Ref:			Condition / Damage:	0		
Survey date:	12/06/2025		Surface Treatment:	2		
Date last inspected:	29/04/2025 14:28:26		Asbestos Type:	2		
Next inspection due:	12th June 2026		Material Score:	7		
Building:	901598 - Gloucester Kings Sq CO	Priority Assessment	Occupant Activity:	0		
Floor level:	Z-Sub Level 1		Location:	2		
Room:	001/Plant Room		Accessibility:	2		
Position:	Wall 3		Extent/amount:	2		20m2
Item Description:	Residue		Number of Occupants:	1		
Level of Identification:	PRESUMED		Frequency of Use:	0		
			Time in Area:	0		
Action:	Monitor and manage		Maintenance activity:	0		
		Frequency of Maintenance:	0			
RISK CODE:	C	Priority Score:	3			
		Total Score:	10			
Comments:					Material Status Change:	
					No Change

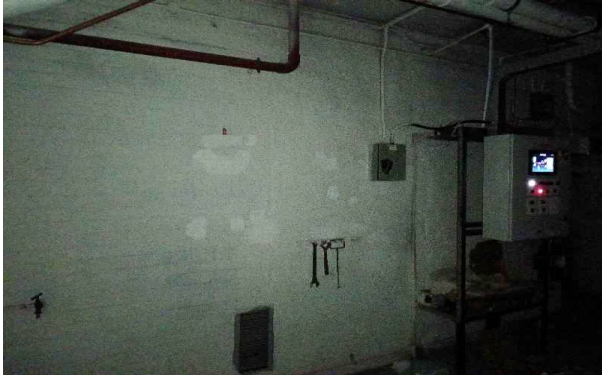
Item / Inspection Ref:	#30	Material Assessment	Product type:	3

Sample Ref:			Condition / Damage:	0		
Survey date:	12/06/2025		Surface Treatment:	2		
Date last inspected:	29/04/2025 14:28:26		Asbestos Type:	2		
Next inspection due:	12th June 2026		Material Score:	7		
Building:	901598 - Gloucester Kings Sq CO	Priority Assessment	Occupant Activity:	0		
Floor level:	Z-Sub Level 1		Location:	2		
Room:	001/Plant Room		Accessibility:	2		
Position:	Wall 4		Extent/amount:	2		20m2
Item Description:	Residue		Number of Occupants:	1		
Level of Identification:	PRESUMED		Frequency of Use:	0		
			Time in Area:	0		
Action:	Monitor and manage		Maintenance activity:	0		
		Frequency of Maintenance:	0			
RISK CODE:	C	Priority Score:	3			
		Total Score:	10			
Comments:					Material Status Change:	
					No Change

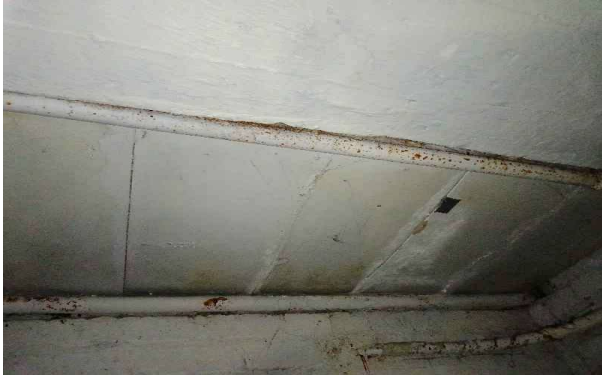
Item / Inspection Ref:	#31	Material Assessment	Product type:	1

Sample Ref:	527949-1 (IMP181430)		Condition / Damage:	1		
Survey date:	12/06/2025		Surface Treatment:	1		
Date last inspected:	29/04/2025 14:28:26		Asbestos Type:	1		
Next inspection due:	12th June 2026		Material Score:	4		
Building:	901598 - Gloucester Kings Sq CO	Priority Assessment	Occupant Activity:	0		
Floor level:	Z-Sub Level 1		Location:	2		
Room:	001/Plant Room		Accessibility:	1		
Position:	Panel		Extent/amount:	1		3m2
Item Description:	Cement panel		Number of Occupants:	1		
Level of Identification:	SAMPLED		Frequency of Use:	0		
Action:	Monitor and manage		Time in Area:	0		
			Maintenance activity:	0		
		Frequency of Maintenance:	0			
RISK CODE:	D	Priority Score:	3			
		Total Score:	7			
Comments:					Material Status Change:	
					No Change

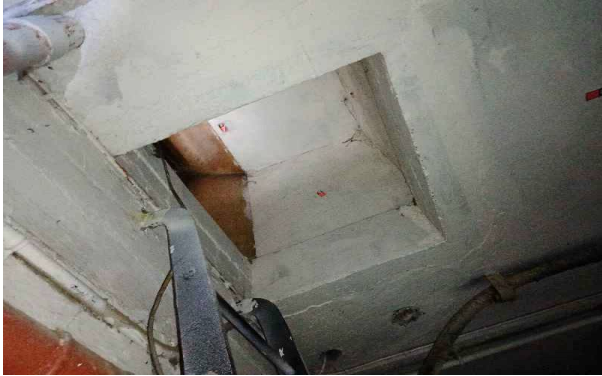
Item / Inspection Ref:	#32	Material Assessment	Product type:	2

Sample Ref:			Condition / Damage:	1		
Survey date:	12/06/2025		Surface Treatment:	1		
Date last inspected:	29/04/2025 14:28:26		Asbestos Type:	3		
Next inspection due:	12th June 2026		Material Score:	7		
Building:	901598 - Gloucester Kings Sq CO	Priority Assessment	Occupant Activity:	0		
Floor level:	Z-Sub Level 1		Location:	2		
Room:	001/Plant Room		Accessibility:	1		
Position:	Upstand panels		Extent/amount:	1		2m2
Item Description:	Insulating board		Number of Occupants:	1		
Level of Identification:	PRESUMED		Frequency of Use:	0		
Action:	Monitor and manage		Time in Area:	0		
			Maintenance activity:	0		
		Frequency of Maintenance:	0			
RISK CODE:	C	Priority Score:	3			
		Total Score:	10			
Comments:					Material Status Change:	
					No Change

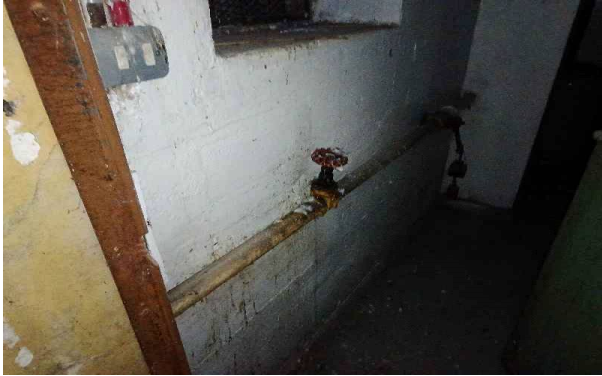
Item / Inspection Ref:	#33	Material Assessment	Product type:	3

Sample Ref:			Condition / Damage:	1		
Survey date:	12/06/2025		Surface Treatment:	2		
Date last inspected:	29/04/2025 14:28:26		Asbestos Type:	2		
Next inspection due:	12th June 2026		Material Score:	8		
Building:	901598 - Gloucester Kings Sq CO	Priority Assessment	Occupant Activity:	0		
Floor level:	Z-Sub Level 1		Location:	2		
Room:	003/Corridor		Accessibility:	2		
Position:	Pipework		Extent/amount:	1		Small amounts
Item Description:	Residue on pipework		Number of Occupants:	1		
Level of Identification:	PRESUMED		Frequency of Use:	0		
Action:	Monitor and manage		Time in Area:	0		
			Maintenance activity:	0		
		Frequency of Maintenance:	0			
RISK CODE:	C	Priority Score:	3			
		Total Score:	11			
Comments:					Material Status Change:	
					No Change

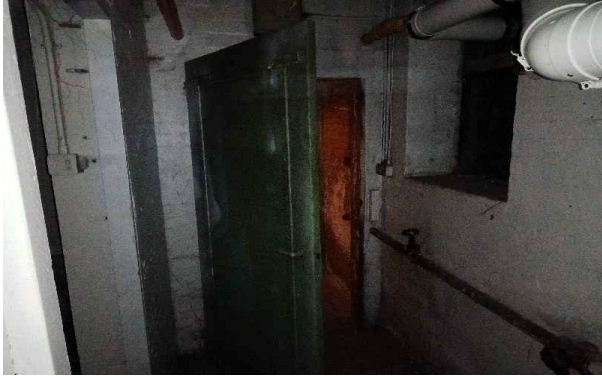
Item / Inspection Ref:	#34	Material Assessment	Product type:	2

Sample Ref:			Condition / Damage:	0		
Survey date:	12/06/2025		Surface Treatment:	1		
Date last inspected:	29/04/2025 14:28:26		Asbestos Type:	2		
Next inspection due:	12th June 2026		Material Score:	5		
Building:	901598 - Gloucester Kings Sq CO	Priority Assessment	Occupant Activity:	0		
Floor level:	Z-Sub Level 1		Location:	2		
Room:	003/Corridor		Accessibility:	1		
Position:	Fire door		Extent/amount:	1		2m2
Item Description:	Insulating board		Number of Occupants:	1		
Level of Identification:	PRESUMED		Frequency of Use:	0		
Action:	Monitor and manage		Time in Area:	0		
			Maintenance activity:	0		
		Frequency of Maintenance:	0			
RISK CODE:	D	Priority Score:	3			
		Total Score:	8			
Comments:					Material Status Change:	
					No Change

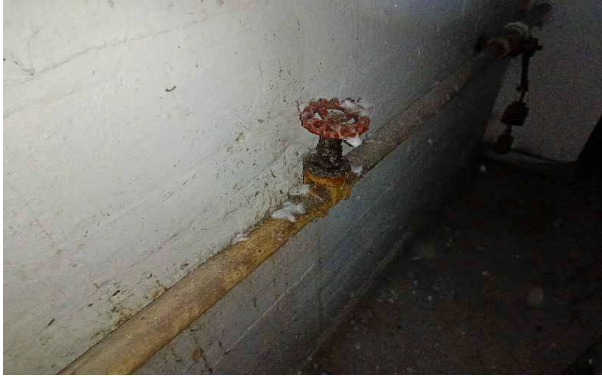
Item / Inspection Ref:	#35	Material Assessment	Product type:	2

Sample Ref:			Condition / Damage:	1		
Survey date:	12/06/2025		Surface Treatment:	2		
Date last inspected:	29/04/2025 14:28:26		Asbestos Type:	1		
Next inspection due:	12th June 2026		Material Score:	6		
Building:	901598 - Gloucester Kings Sq CO	Priority Assessment	Occupant Activity:	0		
Floor level:	Z-Sub Level 1		Location:	2		
Room:	003/Corridor		Accessibility:	0		
Position:	Valve flange		Extent/amount:	0		1no.
Item Description:	Valve flange packing		Number of Occupants:	1		
Level of Identification:	PRESUMED		Frequency of Use:	0		
Action:	Monitor and manage		Time in Area:	0		
			Maintenance activity:	0		
		Frequency of Maintenance:	0			
RISK CODE:	D	Priority Score:	2			
		Total Score:	8			
Comments:					Material Status Change:	
					No Change

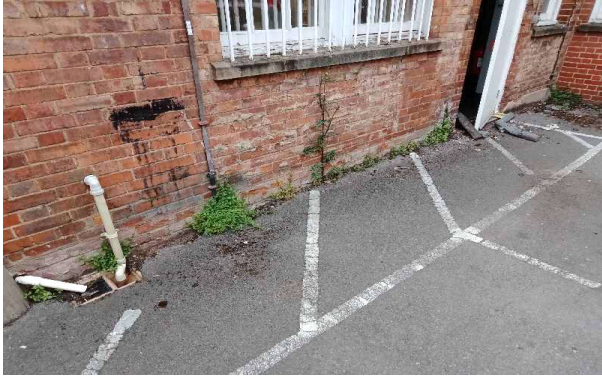
Item / Inspection Ref:	#36	Material Assessment	Product type:	1

Sample Ref:			Condition / Damage:	1		
Survey date:	12/06/2025		Surface Treatment:	0		
Date last inspected:	29/04/2025 14:28:26		Asbestos Type:	1		
Next inspection due:	12th June 2026		Material Score:	3		
Building:	901598 - Gloucester Kings Sq CO	Priority Assessment	Occupant Activity:	1		
Floor level:	External		Location:	0		
Room:	999/External		Accessibility:	0		
Position:	External walls		Extent/amount:	3		100lm
Item Description:	Damp proof course		Number of Occupants:	0		
Level of Identification:	PRESUMED		Frequency of Use:	0		
Action:	Monitor and manage		Time in Area:	0		
			Maintenance activity:	0		
		Frequency of Maintenance:	0			
RISK CODE:	D	Priority Score:	2			
		Total Score:	5			
Comments:					Material Status Change:	
					No Change

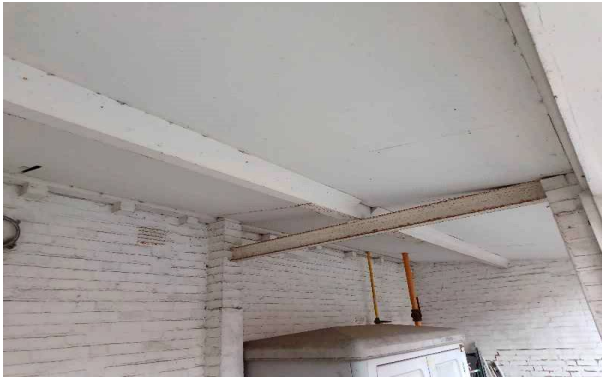
Item / Inspection Ref:	#38	Material Assessment	Product type:	2

Sample Ref:			Condition / Damage:	1				
Survey date:	12/06/2025		Surface Treatment:	1				
Date last inspected:	29/04/2025 14:28:26		Asbestos Type:	2				
Next inspection due:	12th June 2026		Material Score:	6				
Building:	901598 - Gloucester Kings Sq CO	Priority Assessment	Occupant Activity:	0				
Floor level:	External		Location:	0				
Room:	999/External		Accessibility:	0				
Position:	Ceiling panels to rear structure		Extent/amount:	2	15m2			
Item Description:	Insulating board		Number of Occupants:	0				
Level of Identification:	PRESUMED		Frequency of Use:	0				
			Time in Area:	0				
			Maintenance activity:	0				
			Frequency of Maintenance:	0				
Action:	Monitor and manage			Priority Score:	1			
RISK CODE:	D			Total Score:	7			
Comments:							Material Status Change:	
							No Change

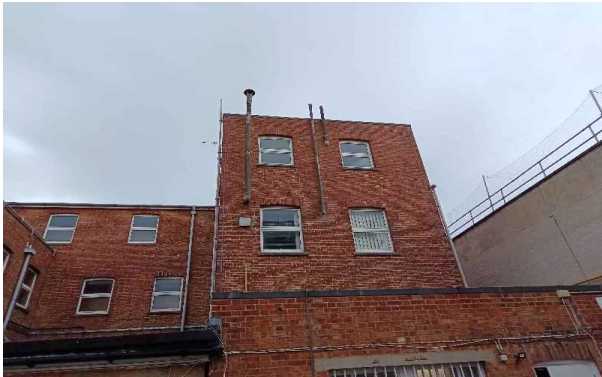
Item / Inspection Ref:	#39	Material Assessment	Product type:	1	
Sample Ref:			Condition / Damage:	1	
Survey date:	12/06/2025		Surface Treatment:	1	
Date last inspected:	29/04/2025 14:28:26		Asbestos Type:	1	
Next inspection due:	12th June 2026		Material Score:	4	
Building:	901598 - Gloucester Kings Sq CO	Priority Assessment	Occupant Activity:	0	
Floor level:	External		Location:	0	
Room:	999/External		Accessibility:	0	
Position:	Rear elevation at high level		Extent/amount:	2	3no.
Item Description:	Cement flue and cowls		Number of Occupants:	0	
Level of Identification:	PRESUMED		Frequency of Use:	0	
			Time in Area:	0	
			Maintenance activity:	0	
			Frequency of Maintenance:	0	
Action:	Monitor and manage		Priority Score:	1	
RISK CODE:	D		Total Score:	5	
Comments:	Approximately 16m linear in total

Material Status Change:
No Change

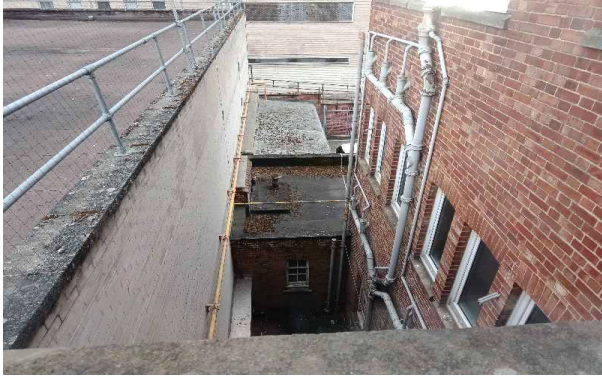
Item / Inspection Ref:	#41	Material Assessment	Product type:	1

Sample Ref:			Condition / Damage:	1		
Survey date:	12/06/2025		Surface Treatment:	1		
Date last inspected:			Asbestos Type:	3		
Next inspection due:	12th June 2026		Material Score:	6		
Building:	901598 - Gloucester Kings Sq CO	Priority Assessment	Occupant Activity:	0		
Floor level:	External		Location:	0		
Room:	999/External		Accessibility:	0		
Position:	Roof over ground floor ladies toilets		Extent/amount:	1	1m	
Item Description:	Cement flue pipe and cowl		Number of Occupants:	0		
Level of Identification:	PRESUMED		Frequency of Use:	0		
			Time in Area:	0		
			Maintenance activity:	0		
			Frequency of Maintenance:	0		
Action:	Monitor and manage					
RISK CODE:	D		Priority Score:	1		
			Total Score:	7		
Comments:	Visible from second floor front left hand side stairwell					Material Status Change:
						Additional Entry
